## Case History:

Joe McCollum  
EnVibe, Inc.  
Houston, Texas

## Carbon Seal Rub on a Steam Turbine

Summary – This article describes the effects and vibration responses when carbon seal rubs are experienced on a steam turbine and procedures for correction.

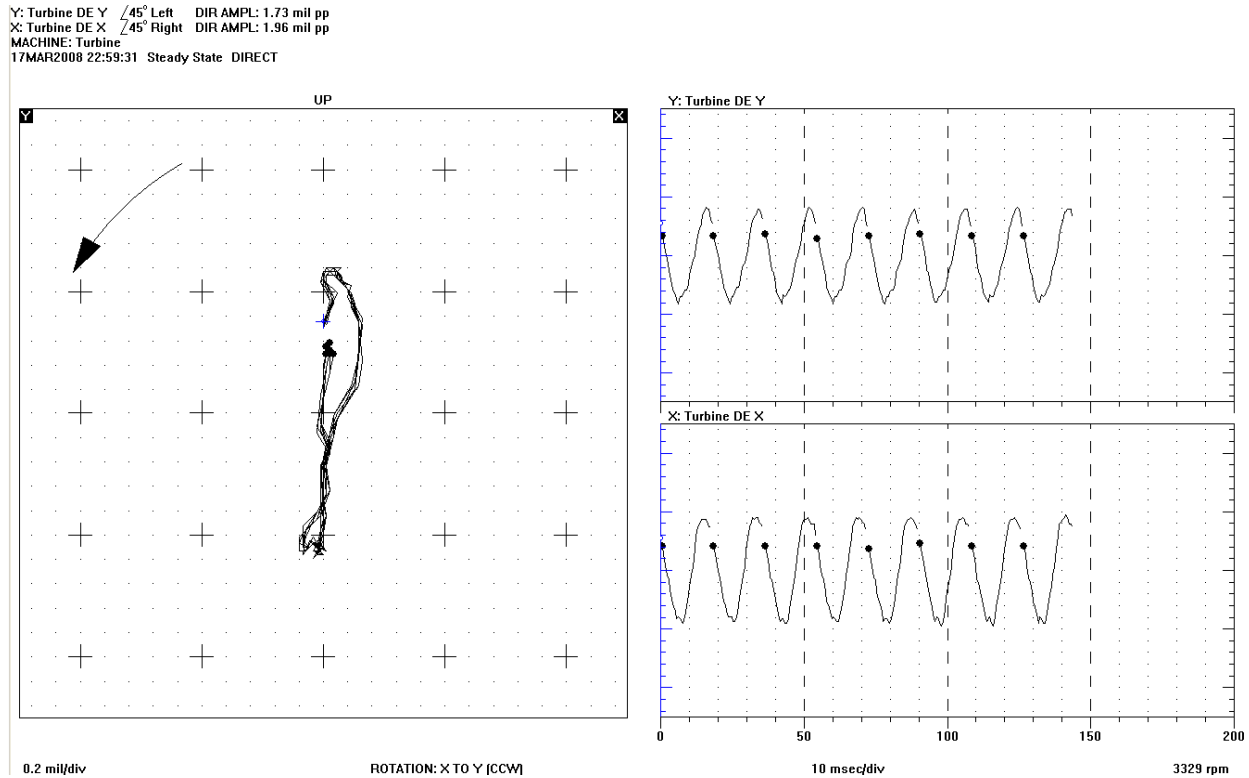
When we came up in speed to 3329 rpm we also noticed the orbit plots would change in pattern, going into a compressed pre-loaded condition. When we would back down in speed a little the orbit would then open up into a low amplitude pattern. When we would come back up to approximately the speed we had previously seen the pre-load, the pattern would stay at low amplitudes.

Figure 3 – Compressed pre-loaded condition at 3329 rpm

After watching this pattern several times during the speed increases we attributed the condition as a rub on the carbon seals. Although the orbit patterns were not typical rub patterns, we believe the carbons were grabbing the shaft and creating the pre-load condition. When the higher amplitudes were experienced during the rub conditions we backed off in speed and allowed the amplitude and rub to settle out. Then when we came back up to the speed we saw the rub at, the seals had been “rubbed in” enough to allow the shaft clearances and eliminate the rub. We proceeded with this “rub in” process until full operating speed (3880 rpm) was achieved. Our final amplitudes at operating speed was less than a mil at all of the turbine probes.

Although the standard correction for this problem would be to order the correct carbon seals for the specified application, we were able to get this machine back on line and operating until the proper seals could be ordered.

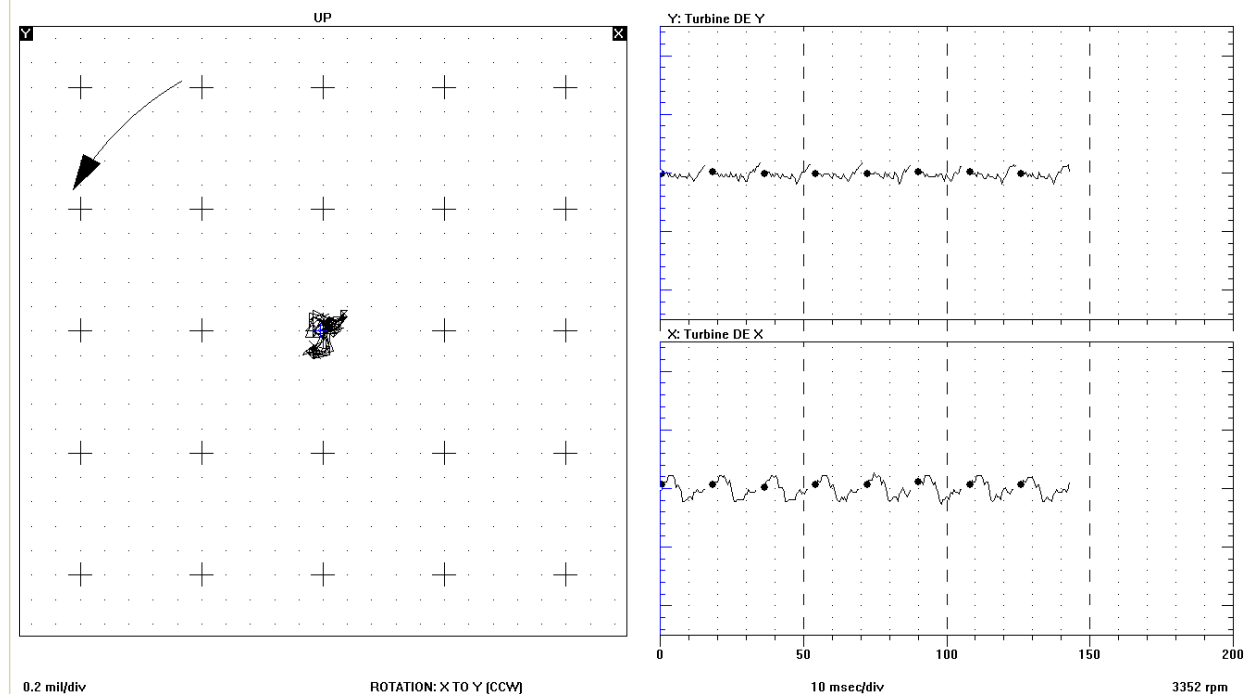
Figure 4 – Normal low amplitude condition at 3352 rpm
