## Case History:

Joe McCollum  
EnVibe, Inc.  
Houston, Texas

## Carbon Seal Rub on a Steam Turbine

Summary – This article describes the effects and vibration responses when carbon seal rubs are experienced on a steam turbine and procedures for correction.

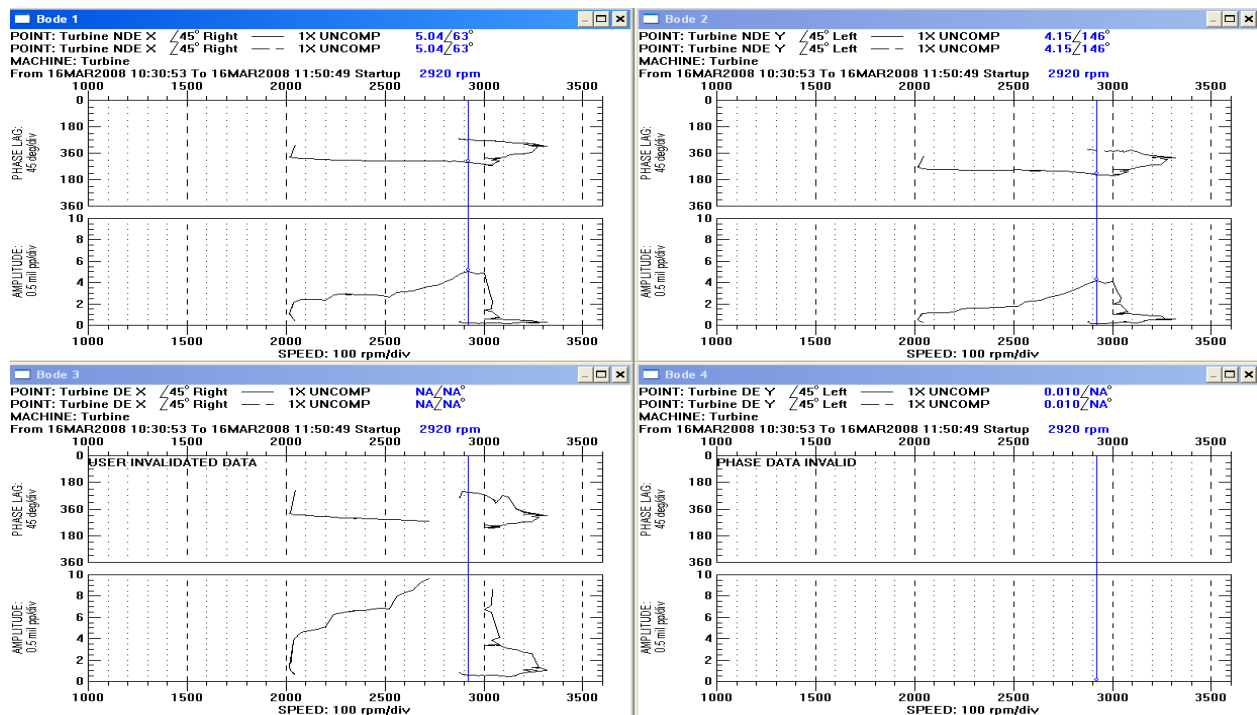
The initial set of data, captured during the start up, revealed high vibration amplitudes at the drive end X turbine bearing probe that eventually increased to trip conditions and shut the unit down. During the excursion the amplitude overloaded our set point of 10 Mills on the data collector. The bearing clearances for the drive end bearing is .008 " and therefore we were concerned about the bearing condition after this 10 + mil excursion. Case vibration at the same bearing position was also extreme at .8 In/Sec pk. We also noted that the drive end Y probe was not working correctly.

Figure 1 - Initial start up response on the turbine proximity probes.

After this initial start up we recommended an internal inspection of the turbine bearings and correction of the drive end Y probe. The proximity probe was found to have an incorrect gap setting and was corrected. The drive end turbine bearing was indeed damaged during the start up and replaced. During the inspection we also looked at the carbon seals and found several rub spots. When asked if they had an extra set of carbons we were given a set manufactured by a source other than the turbine manufacturer. After measuring the I.D. of the seals we found that the clearance was tighter than suggested by the turbine manufacturer and the temperature rating was not to the recommended specifications. The carbons used on the previous run were from the same manufacturer but had a little more clearance. Since we were under the gun to get this machine up and running we decided to go with the same seals used on the previous run.

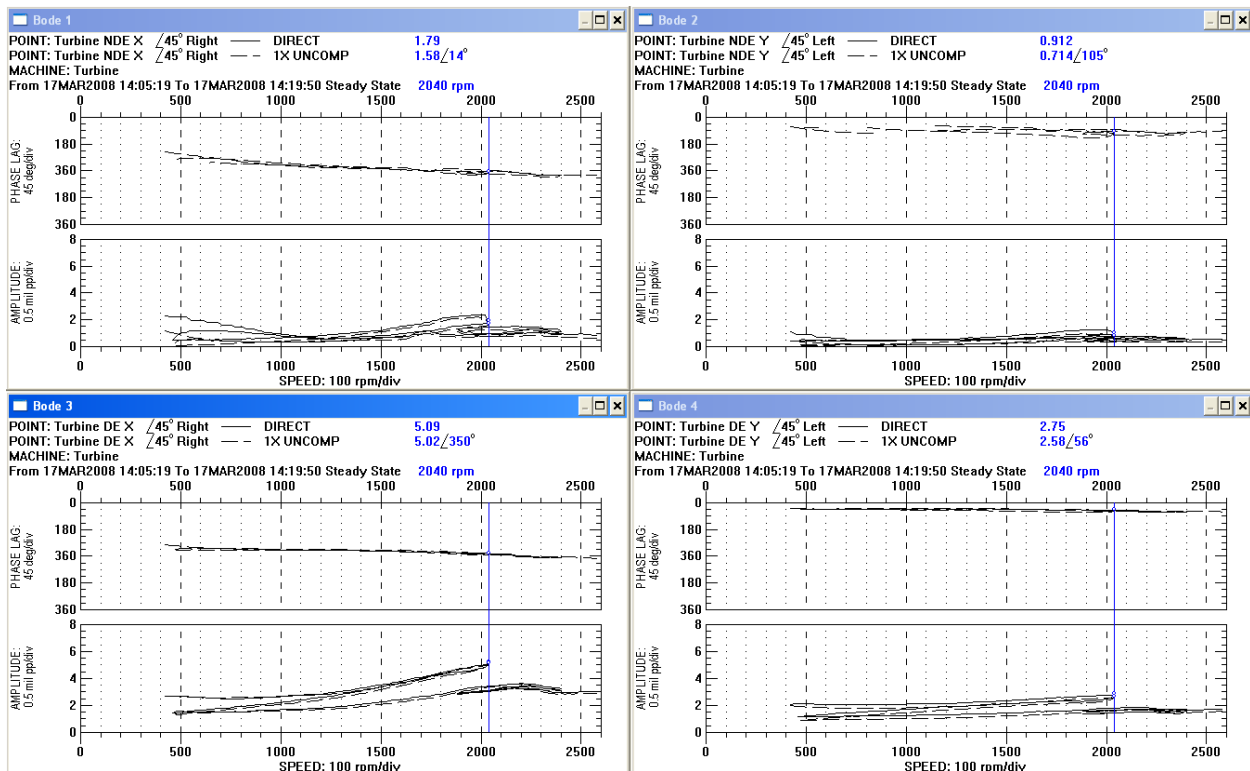
The next run revealed a steady increase in amplitude with speed and eventually reached 5.02 mils on the drive end X probe at 2040 rpm. Since we did not want a repeat of the bearing failure we backed down in rpm and then started bringing the unit back up slowly. We did not experience a repeat of the 5.02 mil excursion but the amplitude did reach 3.37 mils at 2200 rpm and then leveled off to 2.88 mils at 2580 rpm.

Figure 2 – Second start up after bearing replacement and probe corrections

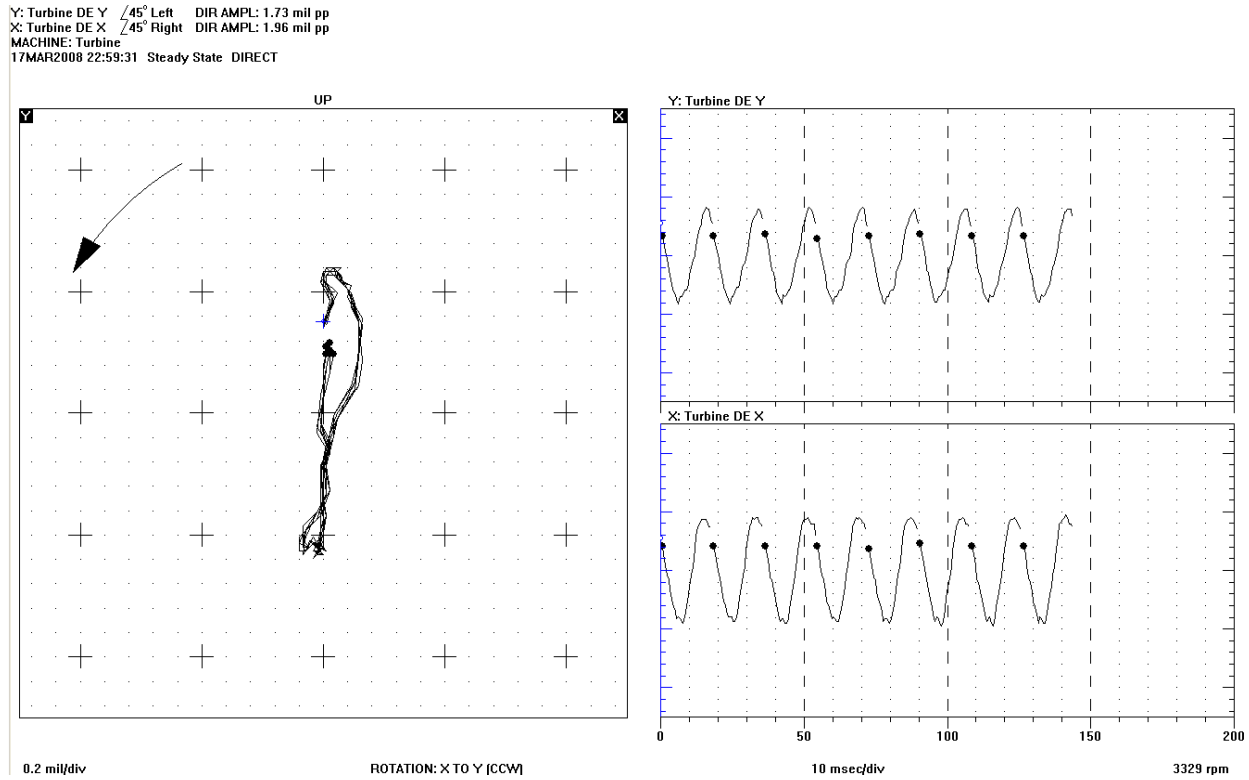
When we came up in speed to 3329 rpm we also noticed the orbit plots would change in pattern, going into a compressed pre-loaded condition. When we would back down in speed a little the orbit would then open up into a low amplitude pattern. When we would come back up to approximately the speed we had previously seen the pre-load, the pattern would stay at low amplitudes.

Figure 3 – Compressed pre-loaded condition at 3329 rpm

After watching this pattern several times during the speed increases we attributed the condition as a rub on the carbon seals. Although the orbit patterns were not typical rub patterns, we believe the carbons were grabbing the shaft and creating the pre-load condition. When the higher amplitudes were experienced during the rub conditions we backed off in speed and allowed the amplitude and rub to settle out. Then when we came back up to the speed we saw the rub at, the seals had been “rubbed in” enough to allow the shaft clearances and eliminate the rub. We proceeded with this “rub in” process until full operating speed (3880 rpm) was achieved. Our final amplitudes at operating speed was less than a mil at all of the turbine probes.

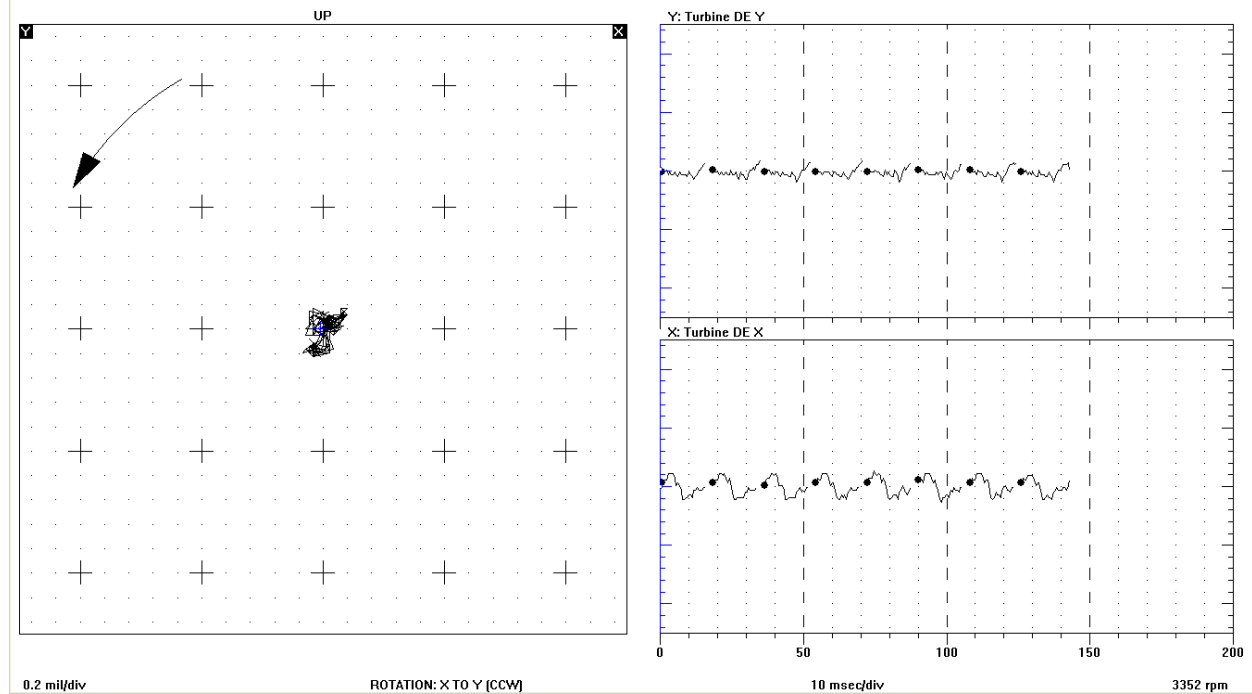
Figure 4 – Normal low amplitude condition at 3352 rpm

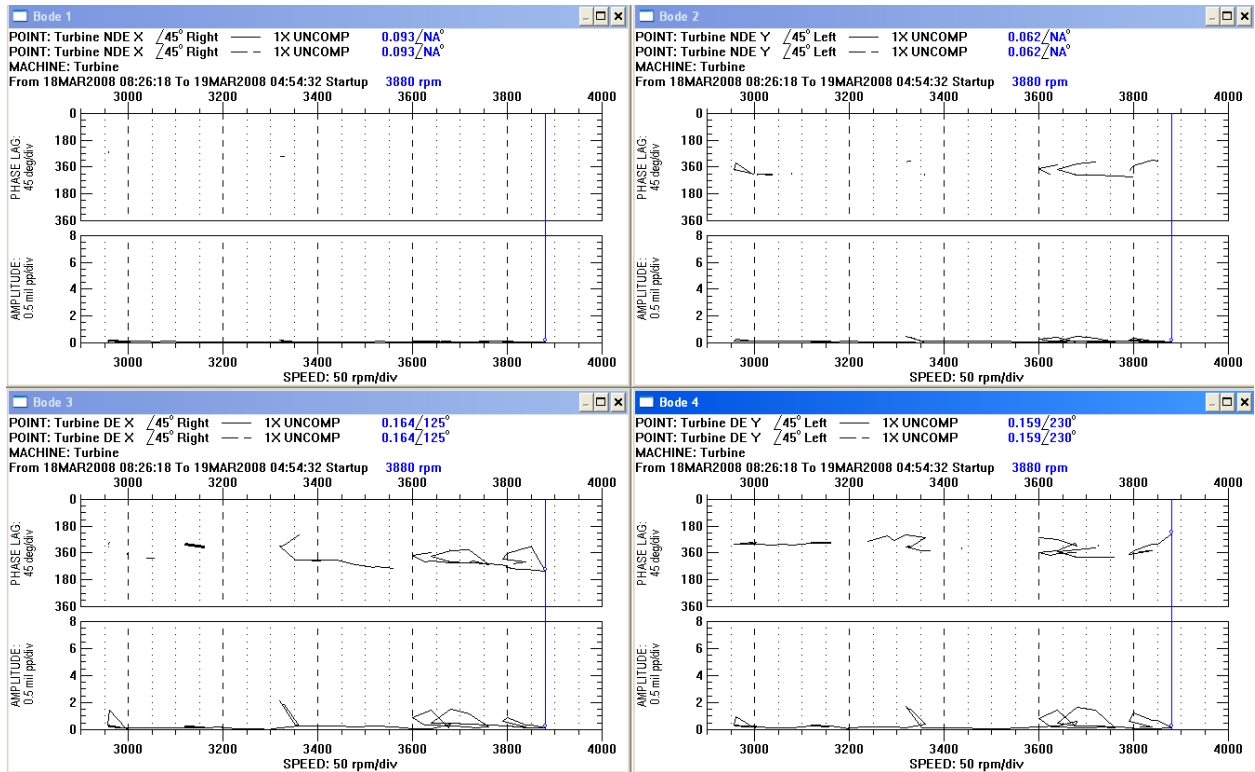
Figure 5 – “Rub in” process up to 3880 rpm

Although the standard correction for this problem would be to order the correct carbon seals for the specified application, we were able to get this machine back on line and operating until the proper seals could be ordered.
